T-109
210109534

INVENTORY FORM FOR STATE HISTORIC SITES SURVEY

Hedrick Farm

NATIONAL REGISTER OF HISTORIC PLACES
INVENTORY - NOMINATION FORM

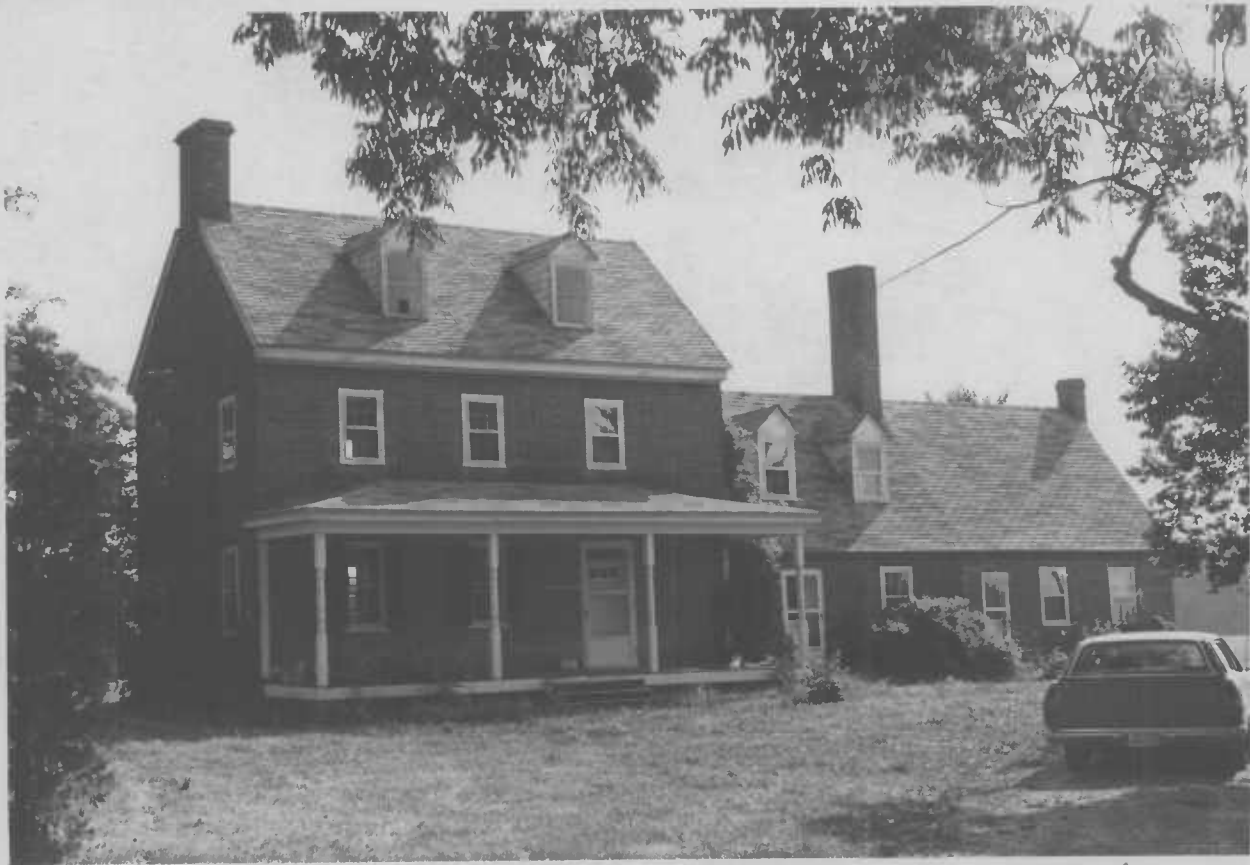
Hedrick Farm

The southwest facade of the building is laid in Flemish bond, whereas, the other sides are laid in common bond. There is neither watertable nor belt course, however, there is a two brick corbeled cornice on the lower wing. A portion of the southeast end has been relaid with new brick, probably the result of deterioration due to the constant heat of the kitchen fireplace.
